भारत सरकार / GOVERNMENT OF INDIA
पत्तन, पोत परिवहन और जलमार्ग मंत्रालय
MINISTRY OF PORTS, SHIPPING AND WATERWAYS
नौवहन महानिदेशालय, मुंबई
DIRECTORATE GENERAL OF SHIPPING, MUMBAI

DGS Circular – 23 of 2024

Sub.: Safety Measures to be followed by personnel on entry into enclosed spaces following Recent Incidents at Indian Ports–reg.

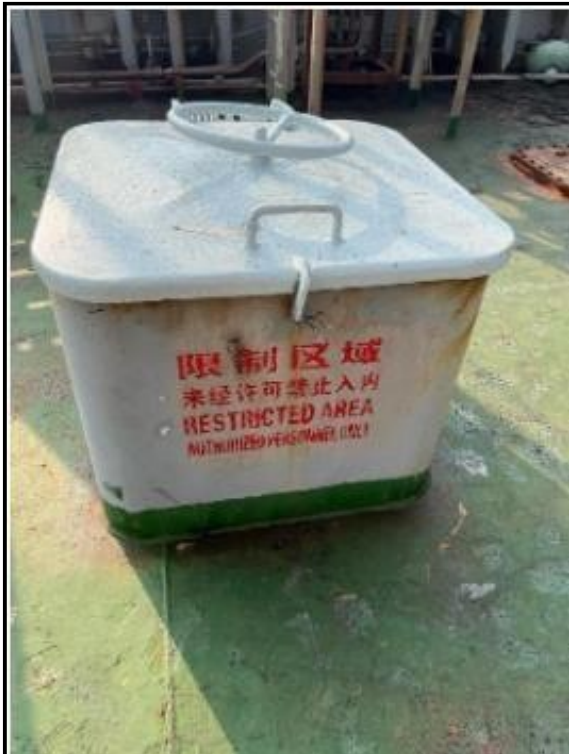
Figure 1: No: 5 Booby hatch with lashing wire (number not marked) – Incident 1

1. The cargo hold bobby hatches were found painted and the stenciling of hold numbers missing. It was also observed that the bobby hatches of the hold were padlocked and some of them were wire lashed. The present incident hold found to be wire lashed with seizing wire.

2. Even though they were wire lashed, the shore gang opened it by themselves and entered the wrong bobby hatch which is in between # 5 and # 6 holding without informing the ship staff.

3. Without realizing and without taking any precautions, the stevedores entered the wrong bobby hatch of the #5 Australian ladder enclosed space where the atmosphere was oxygen deficient and rich in methane.

1. **Access Control:** Vessels shall ensure that all enclosed and restricted spaces are not accessed by shore personnel unless duly authorized by the shipboard personnel. Booby hatches of unused Cargo holds should be kept closed and locked. Accesses to shore personnel to enclosed spaces are to be authorized and controlled by ships personnel. All accesses should remain adequately marked for identifying the spaces they serve, especially when maintenance has been done on them.

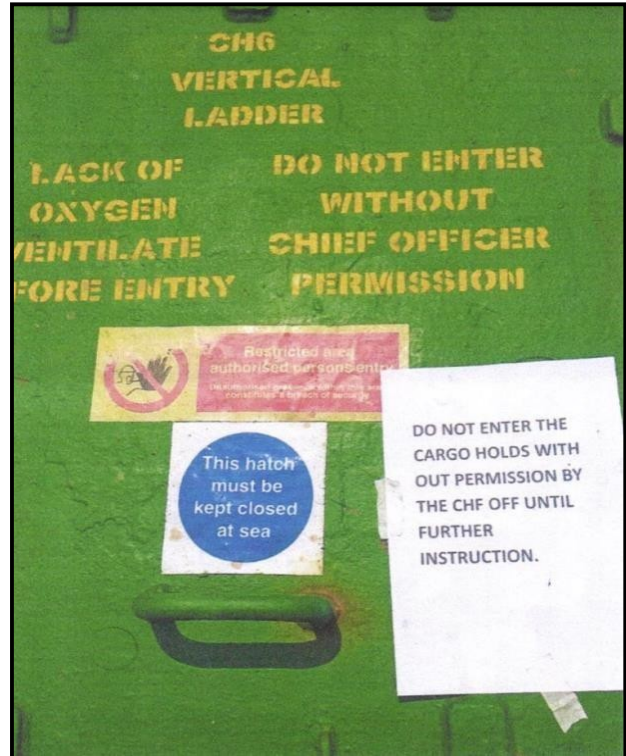
Figure 2: Notices outside the booby hatch (Incident 2)

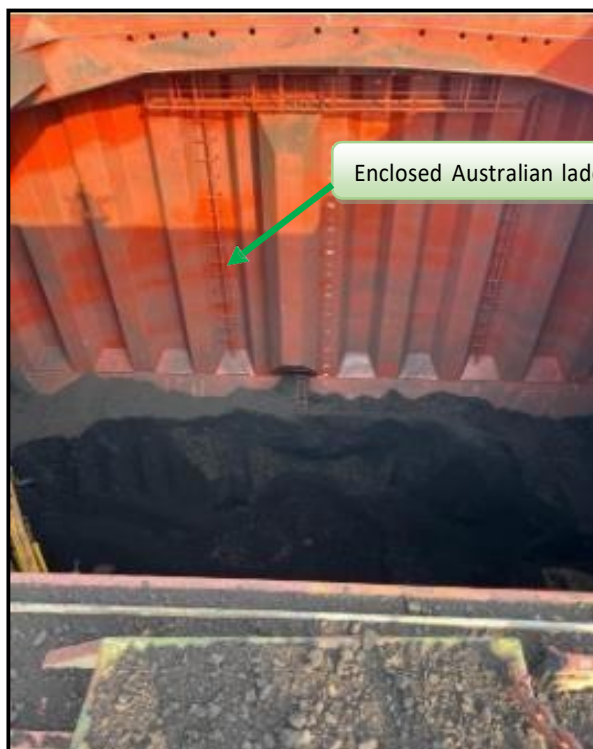
4. The vessel had completely enclosed Australian ladders in the hold. Design of completely enclosed Australian ladders had access on top from the deck and opening at the bottom. This design solved the problem of keeping the Australian ladder safe and secure and minimized the accumulation of cargo residues. But one dangerous situation that was left behind was the filling up of toxic gases of the cargo inside the tunnel.

5. Hatch covers were opened prior to discharging cargoes in a cargo hold and as a result, toxic gases in the cargo hold slowly get diluted/dissipated with the atmosphere naturally due to more surface area. But the gases in the tunnel do not get diluted like that even though the bobby hatch cover is open from the top. The toxic gases in the tunnel will get diluted and oxygen content will increase only when the bottom opening of the tunnel is well clear of the cargoes i.e. towards the completion of the discharge.

Fig 3: Australian Ladder with enclosed dome

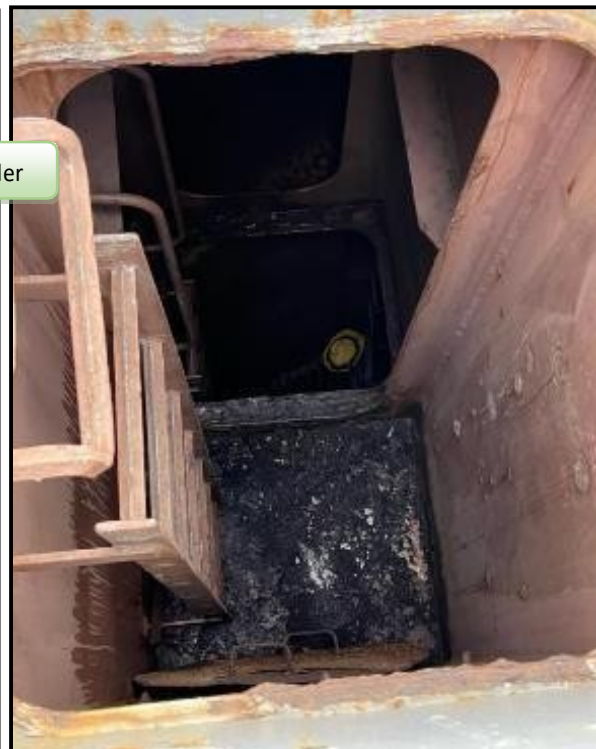
1. The incident occurred as the victim entered Hold No. 4 for cleaning by the vertical ladder which was right but tried to exit from sealed Australian ladder without permission of the Chief Officer.
2. Without realizing and without taking any precautions, the stevedore person entered the hold no # 4 Australian ladder enclosed space where the atmosphere was oxygen deficient and rich in methane. Enclosed nature of Australian ladders makes them more difficult for personnel to escape from in the event of an accident. The absence of proper access points and ventilation

further exacerbates the risks associated with entering enclosed spaces, turning routine tasks into potential death traps.

Figure 4: Location of incident with the helmet of the deceased
